# **Teardown Evaluation of Areas of Interest From the T-34A N141SW Aircraft Wreckage**

March 2006

DOT/FAA/AR-TN05/57

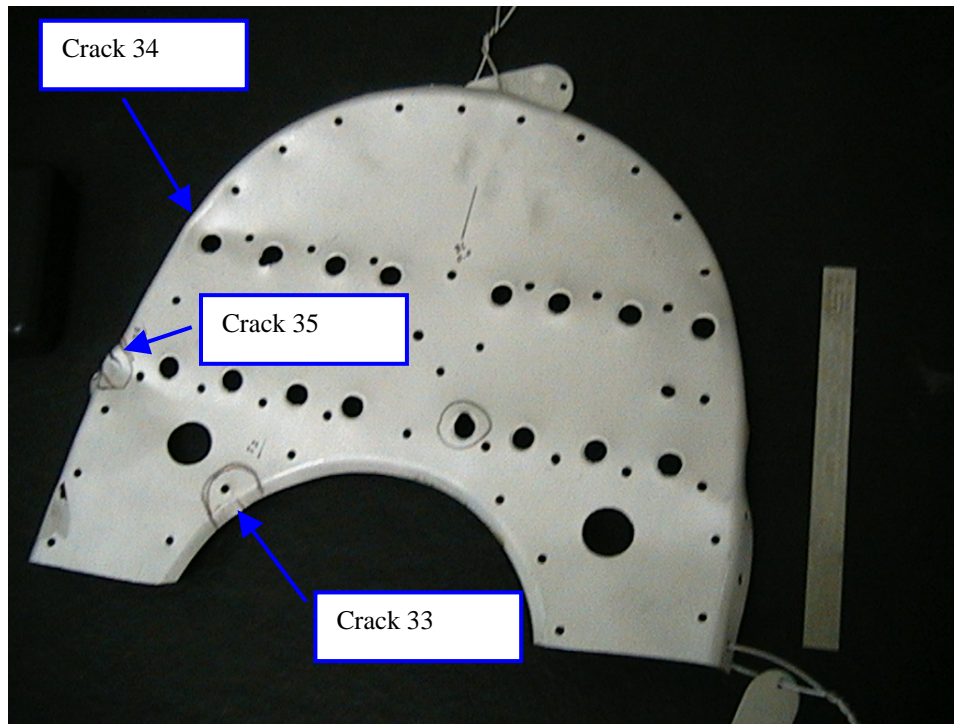
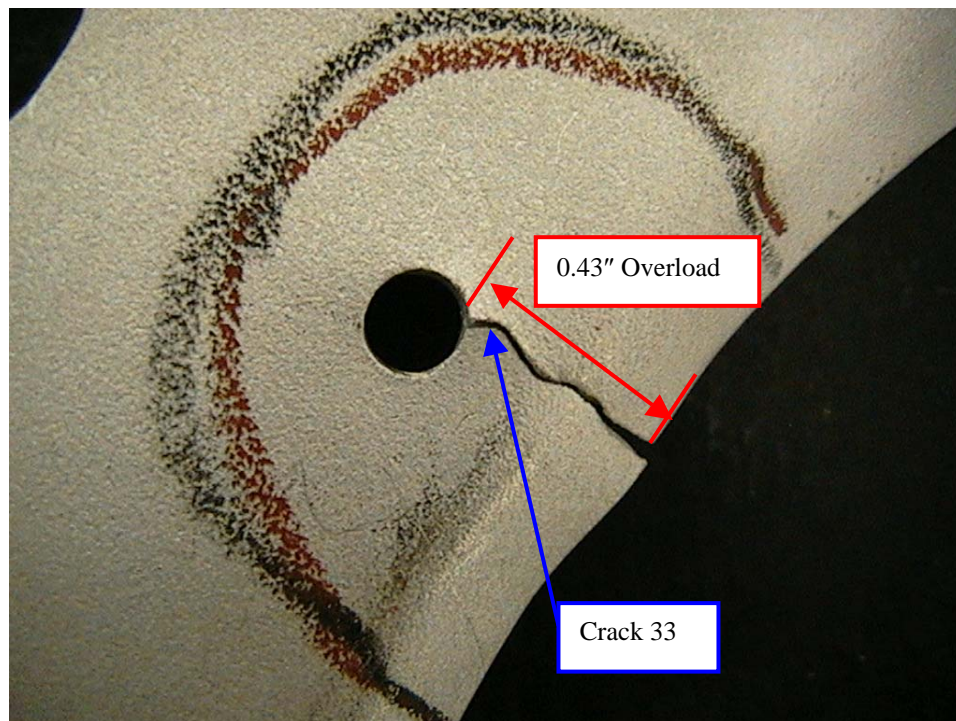
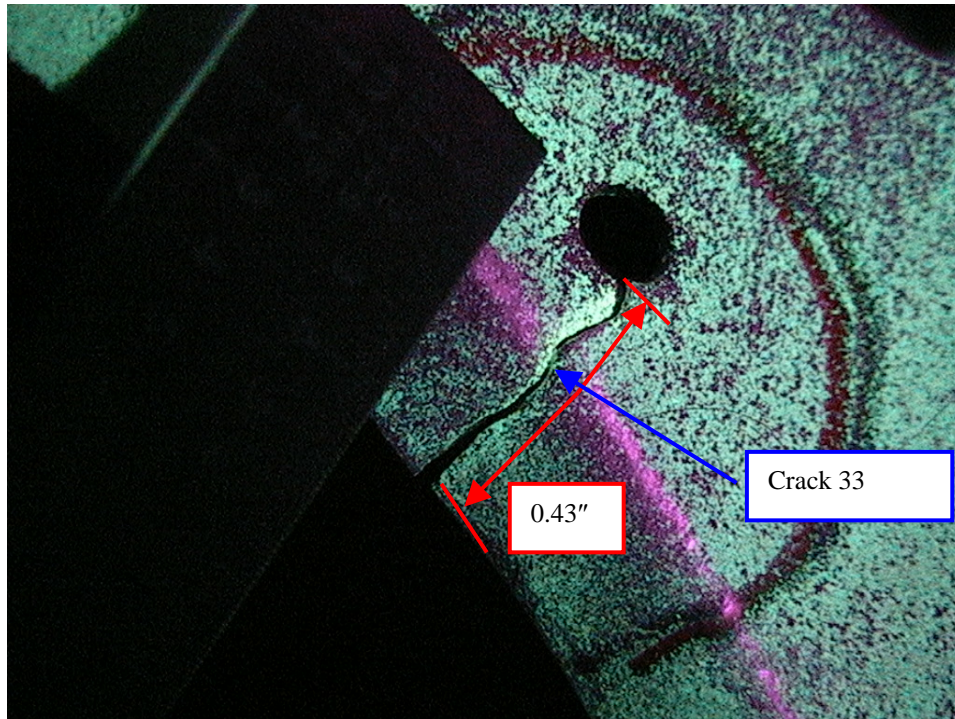
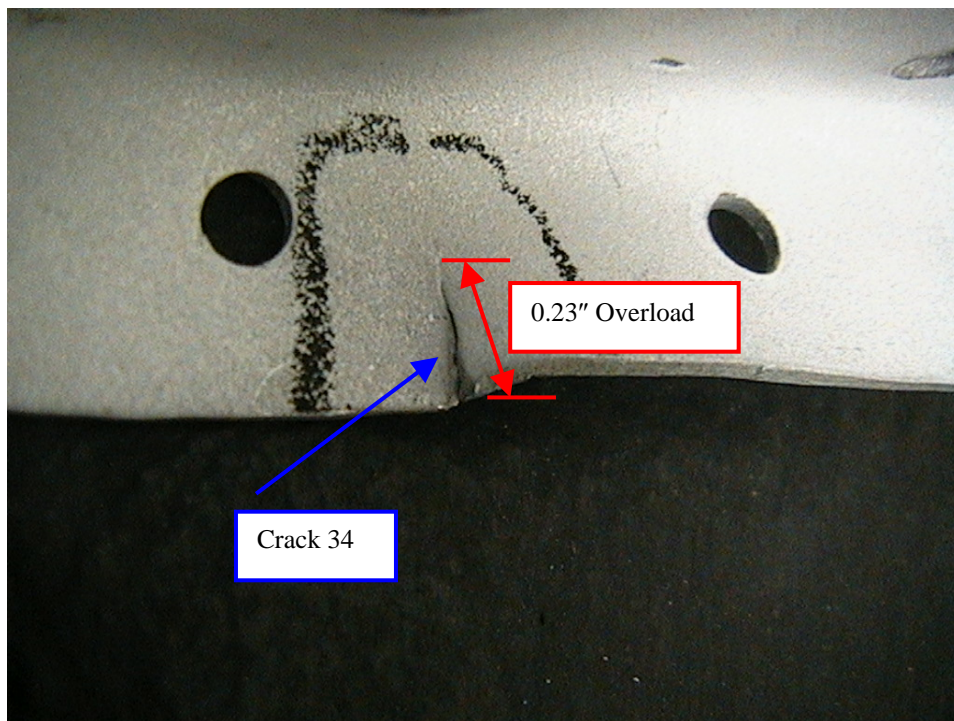
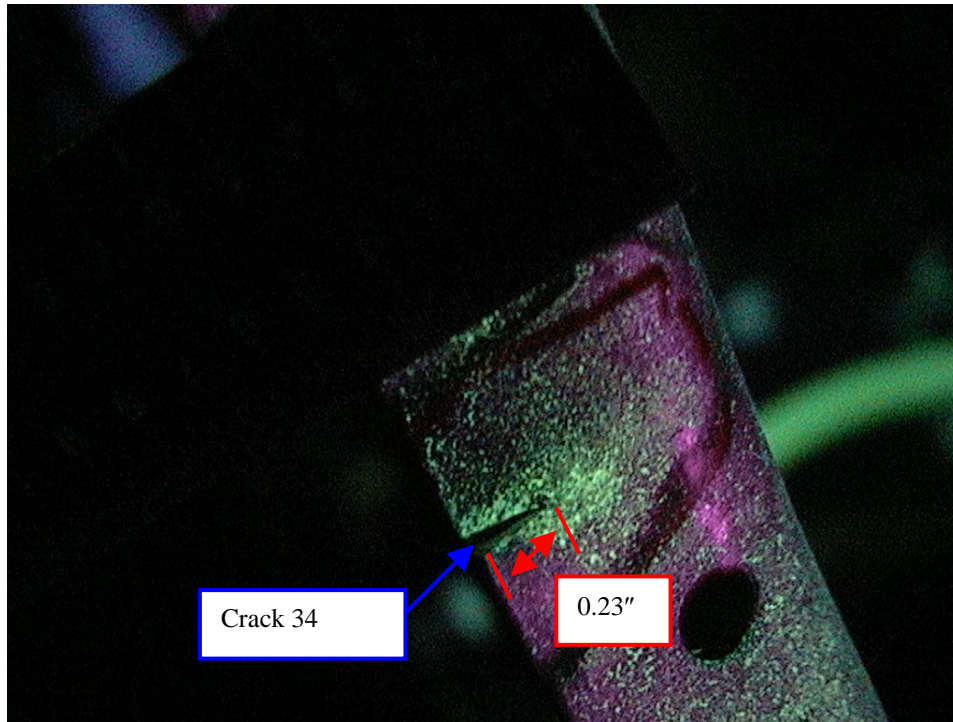
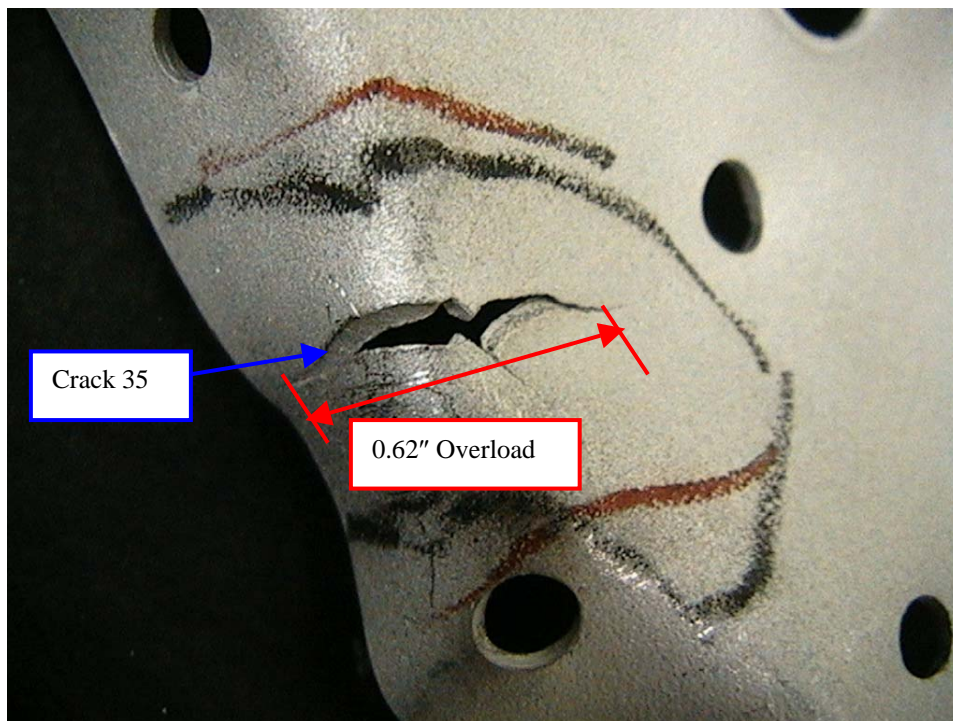
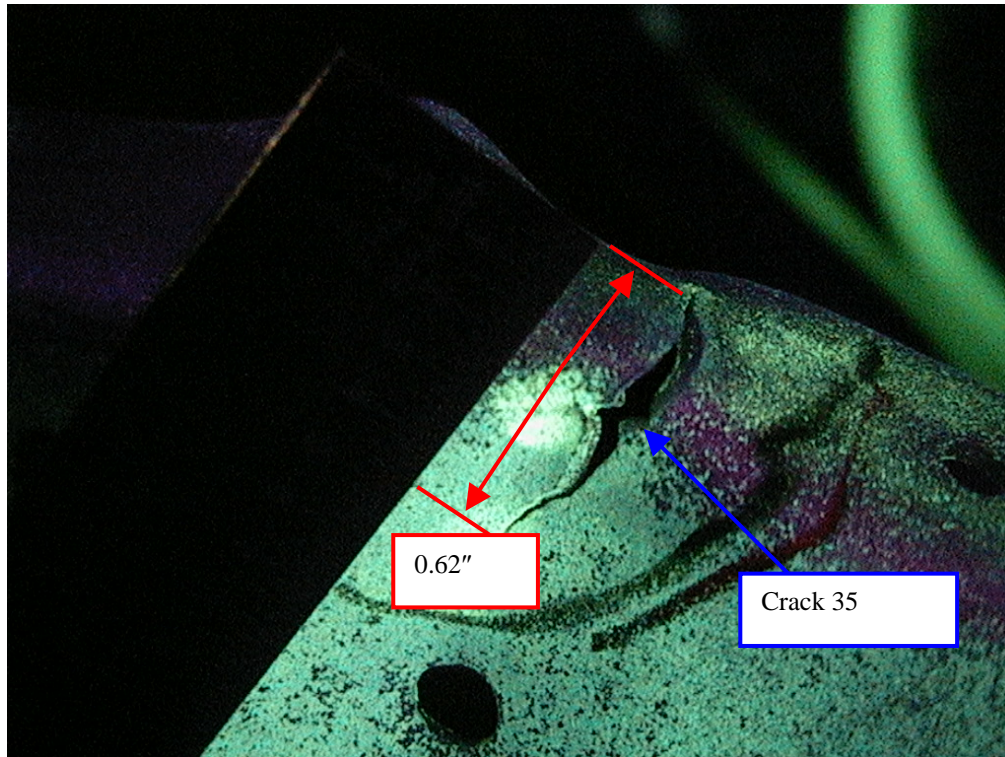
The locations of cracks 33-35 in the horizontal stabilizer bulkhead middle layer are shown in figure 57. Crack 33, shown in figure 58, had a total length of 0.43 inch and was caused by overload, while figure 60 shows crack 34, which had a total length of 0.23 inch that was also caused solely by overload. Pictures taken during the fluorescent liquid penetrant inspections of cracks 33 and 34 are shown in figures 59 and 61, respectively. Figure 62 shows crack 35 with a total length of 0.62 inch. Figure 63 shows this crack under ultraviolet light during the fluorescent liquid penetrant inspections. The only failure mode observed with this crack was overload.

FIGURE 57. LOCATIONS OF CRACKS 33, 34, AND 35 IN THE HORIZONTAL STABILIZER BULKHEAD MIDDLE LAYER

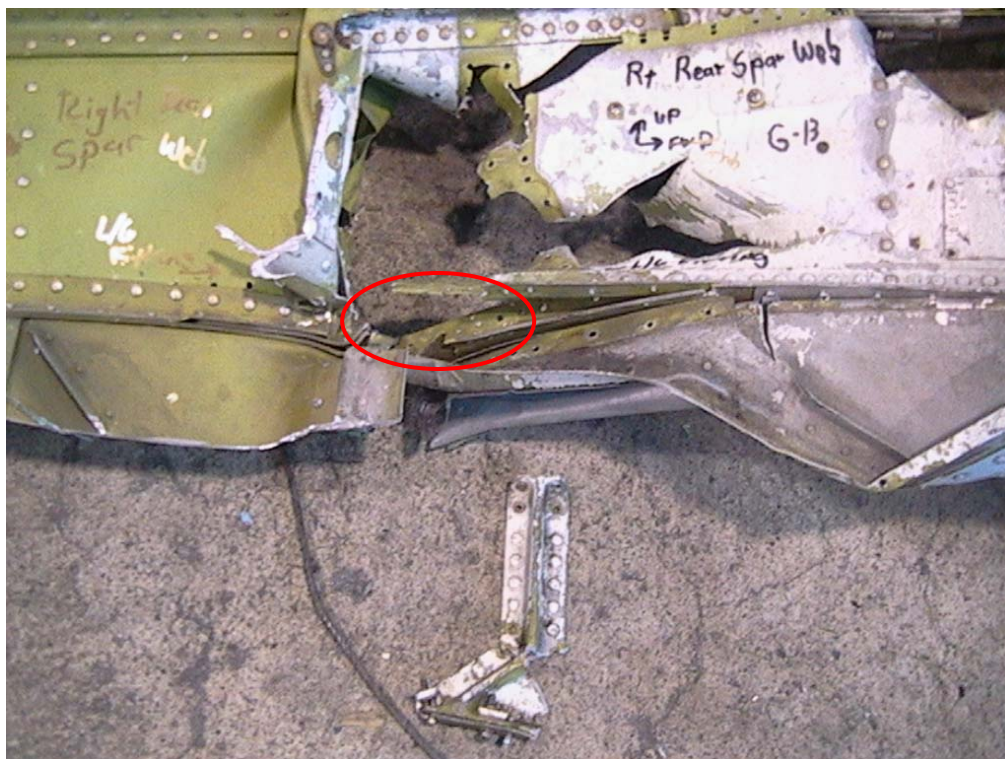
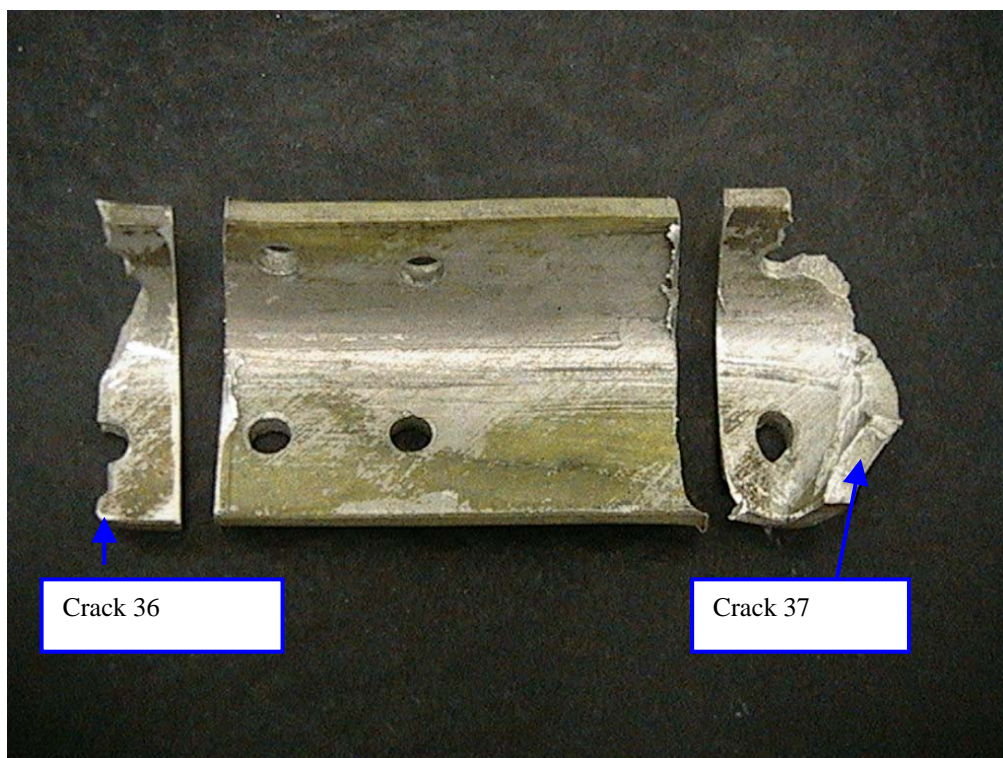
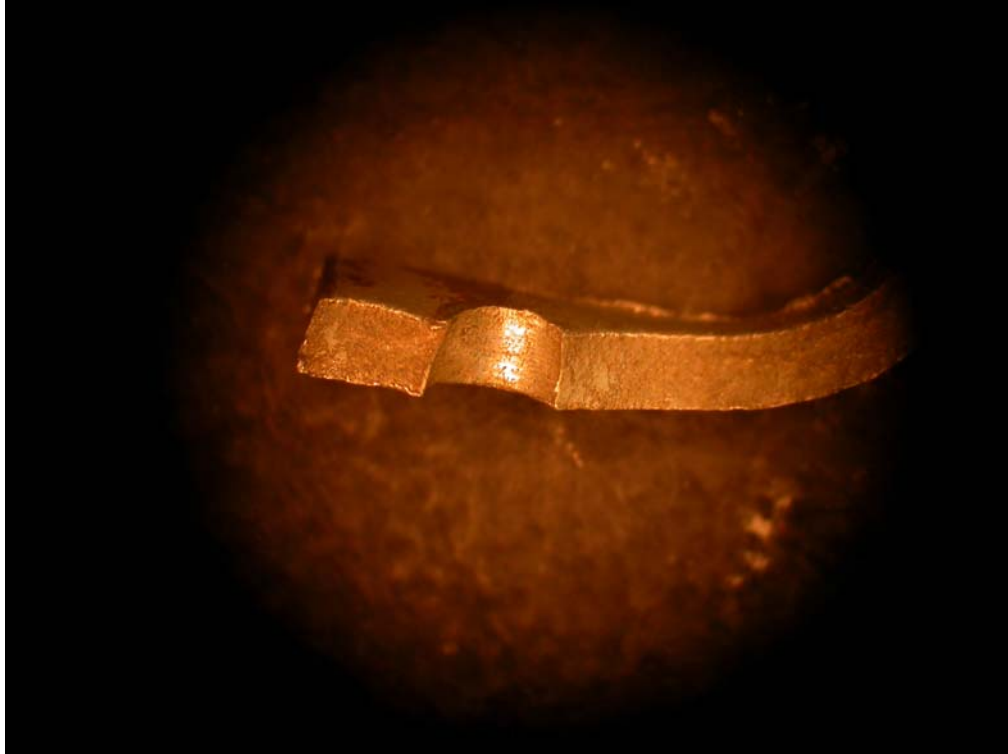
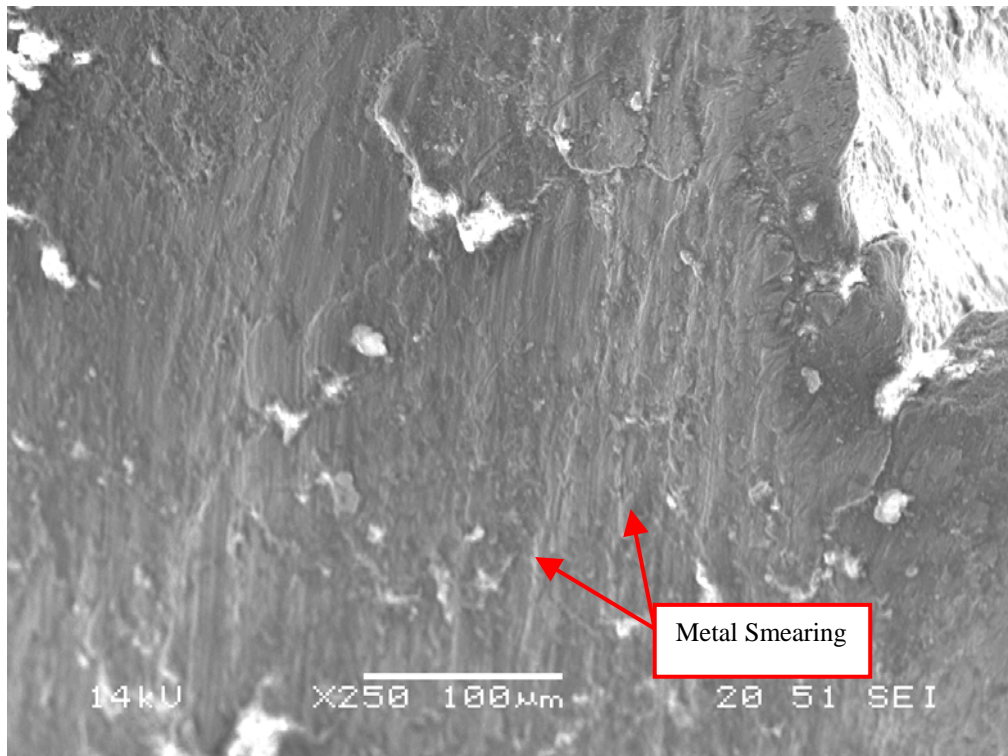
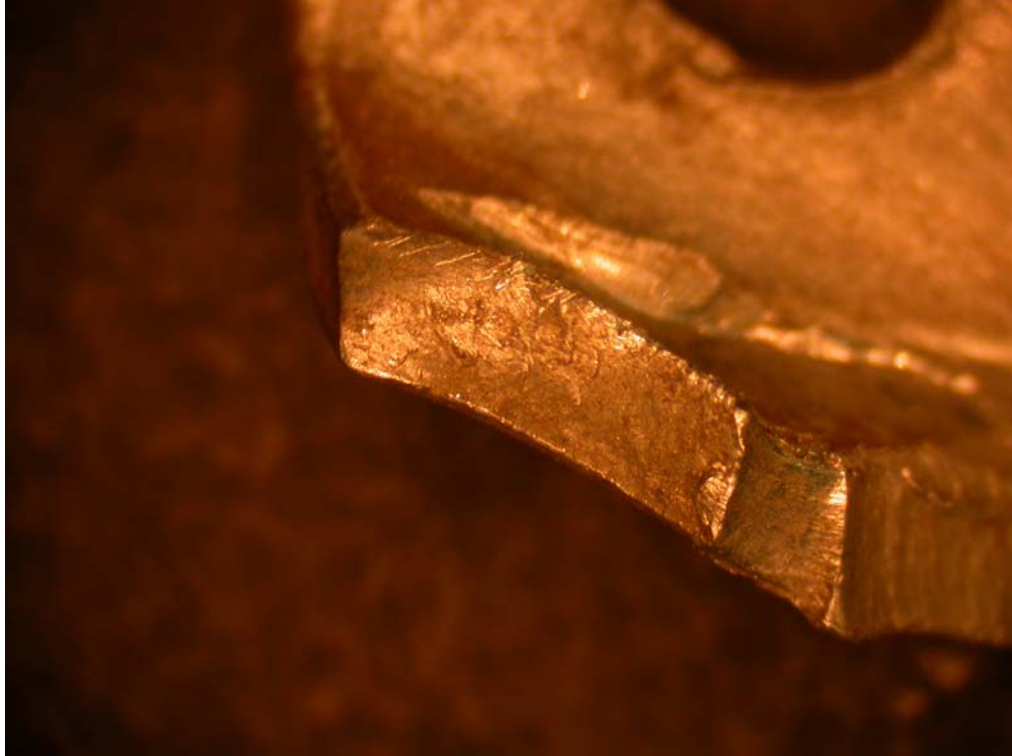
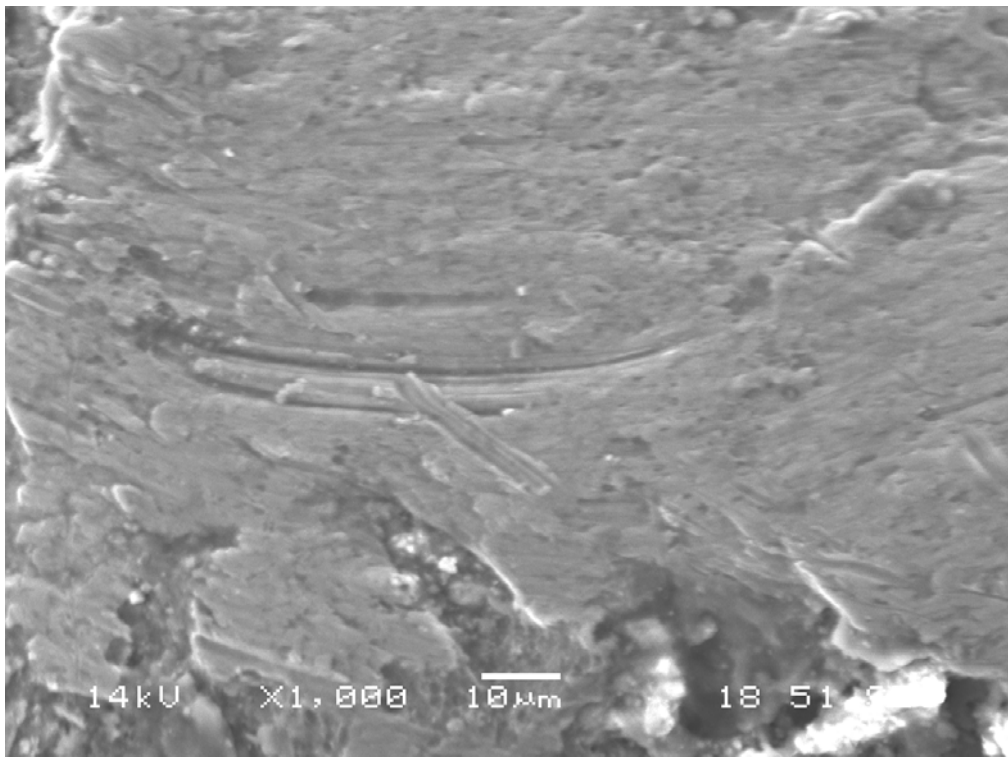
Two 1.187-inch cracks, cracks 36 and 37, were found on the right wing rear spar at WS 66. An overview of this area is provided in figure 64, while a detailed picture is shown in figure 65. The fracture face for crack 36 is shown in figure 66. The SEM fractograph of crack 36, shown in figure 67, shows metal smearing on the face, which masks all evidence of the failure mode. Figure 68 shows the fracture face of crack 37, while figure 69 provides the SEM fractograph. Like crack 36, crack 37 has a significant amount of metal smearing on the fracture face, which masks all evidence of the true failure mode. Therefore, the failure modes of cracks 36 and 37 could not be definitively determined due to smearing of the crack faces.

FIGURE 65. CRACKS 36 AND 37 ON RIGHT WING REAR SPAR WS 66

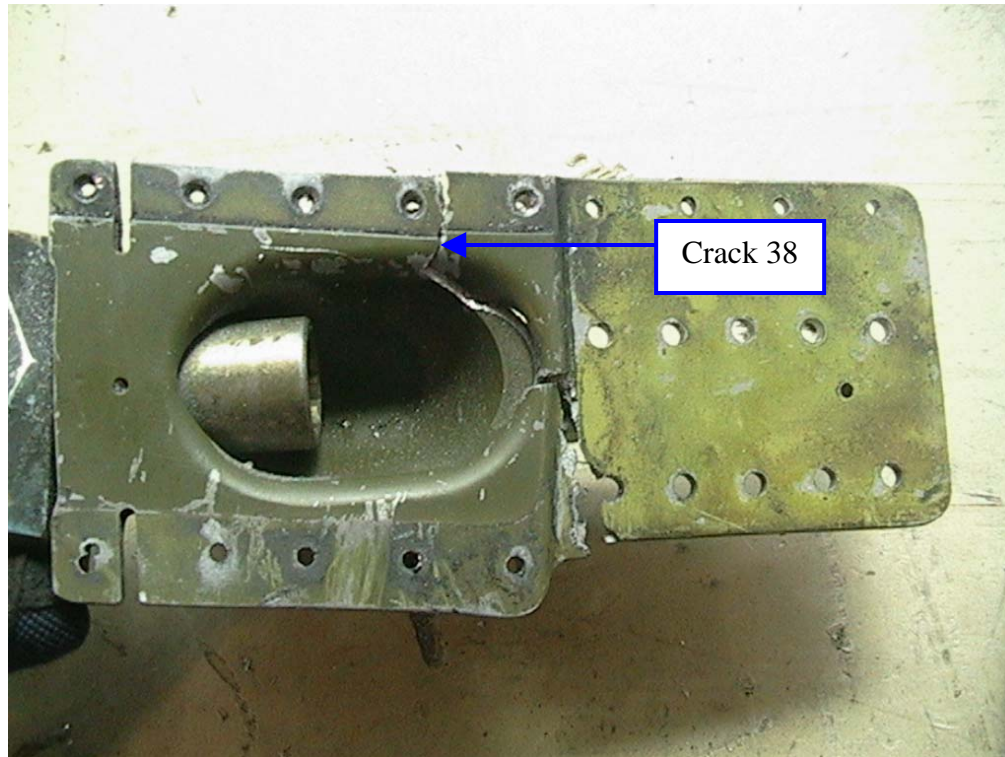
FIGURE 70. RIGHT WING REAR SPAR LOWER BATHTUB FITTING

Crack 38 found on the right wing rear spar lower bathtub fitting, shown in figure 70, was examined, and no evidence of fatigue was found. This crack measured 3.29 inches.
